BOULDER SANITARIUM

HISTORICAL ASSESSMENT

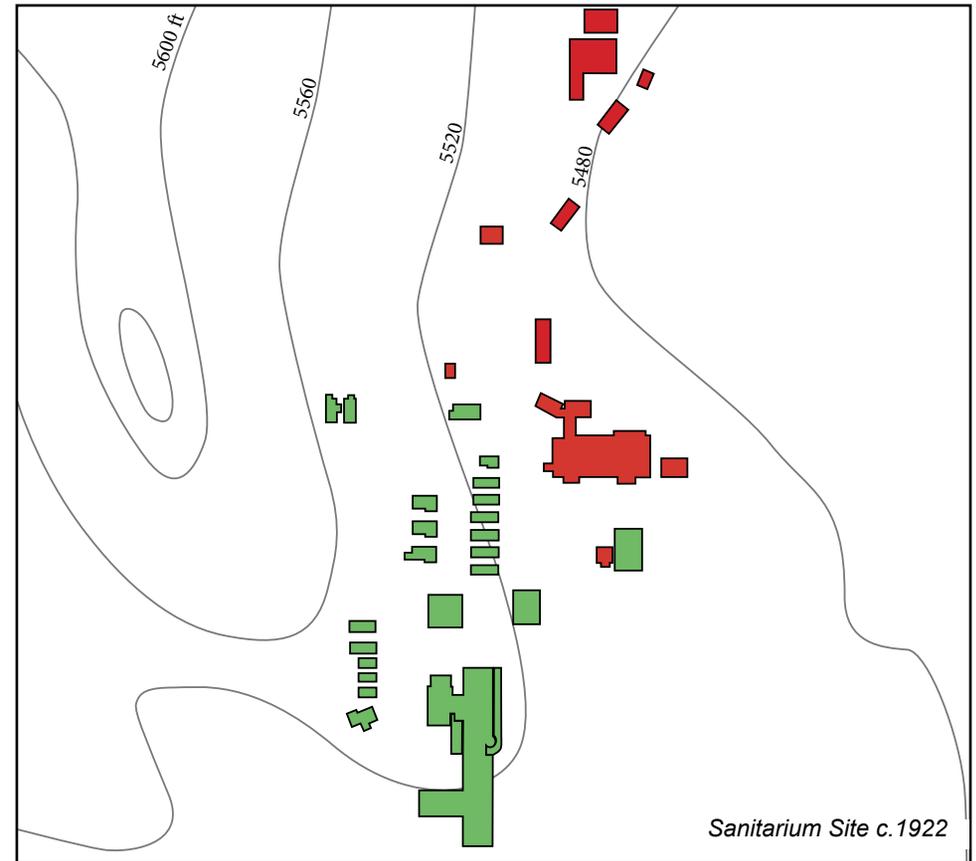
19. Development of the Sanitarium site tended to follow the topography north-south. Generally, buildings that were occupied by guests and patients were farther up the hillside with a better view. Utility and storage buildings were located lower down the hill.

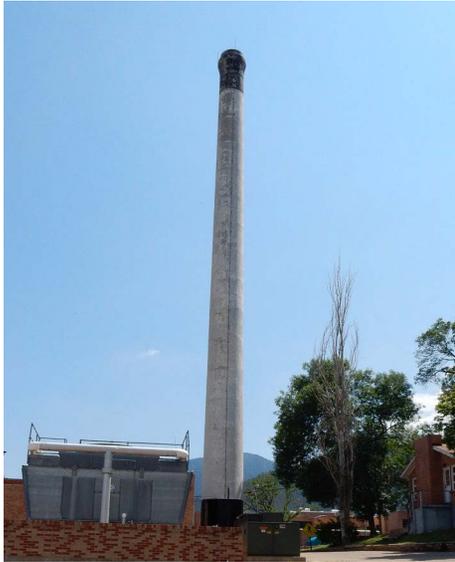
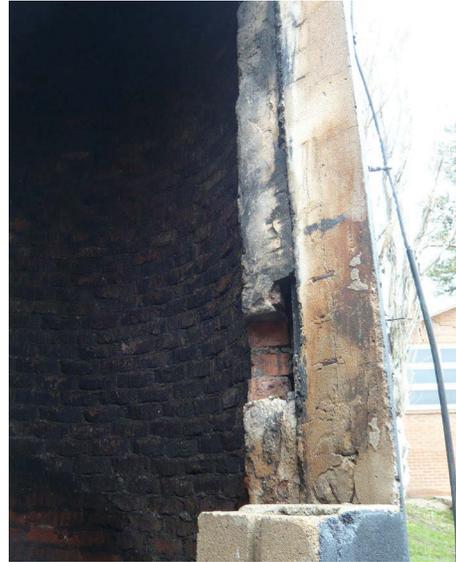
1. SMOKESTACK

20. Looking south at the smokestack.

21. The current smokestack is made of re-enforced concrete and lined with brick

The current concrete stack is actually the fourth iteration of the powerhouse smokestack. Originally, the iron smokestack was located adjacent to the powerhouse building but was moved almost immediately in 1896 after the builders found that the original stack did not provide adequate ventilation. It was then moved roughly 60 feet away higher up the hill and was built of iron. By 1922 the second smokestack was demolished and the third iron stack was built back down the hill, adjacent to the powerhouse. Based on the 1931 Sanborn insurance map it appears that this third smokestack was actually demolished sometime in the mid 1920's. The fourth and final iteration of the smokestack was built just south of where the third stack sat. Unlike the previous versions, this smokestack was built of re-enforced concrete and lined with brick.

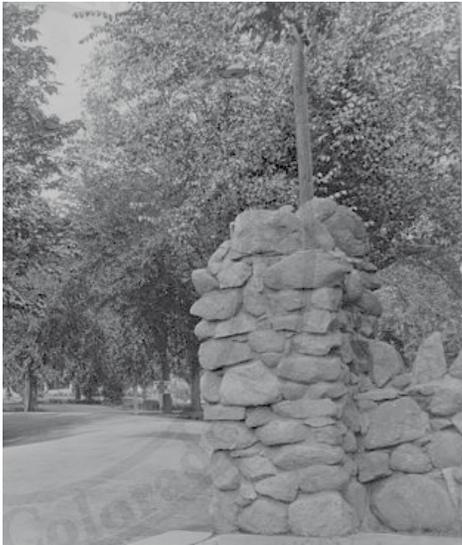
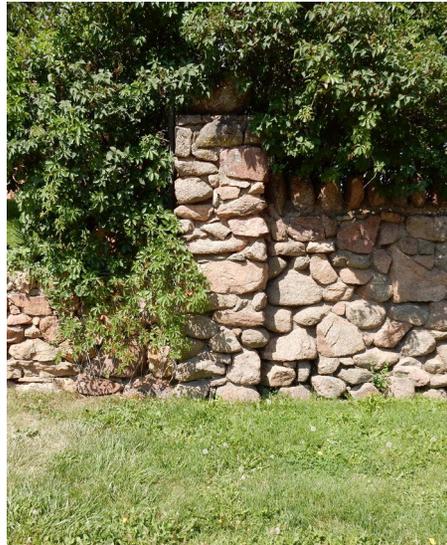
2. STONE WALL

22. A portion of the stone wall appears to be original to the 1920's construction. The left picture dates to c.1929.

A fragment of a stone wall runs along the southern end of the site, fronting Mapleton Avenue. It appears to reflect periods of construction in the late 1920's when the Sanitarium shifted its main entry to allow for easier automobile access. Some portions of the current wall appear to be original to the 1920's construction, but the western-most extension of the wall appears to be more recent and is distinguishable by a change in the rock form, mortar pattern and wall height.

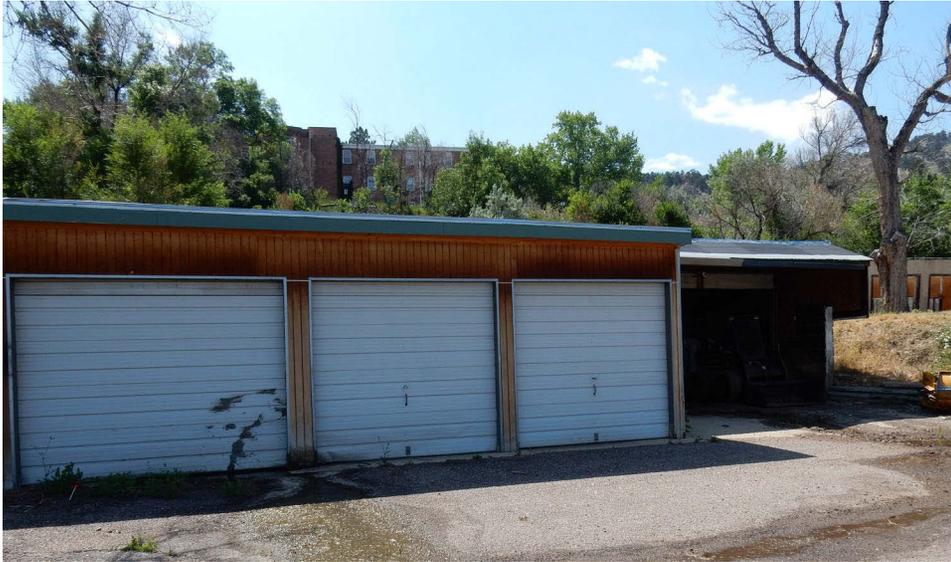
3. FURNITURE STORAGE BUILDING

23. The furniture storage building has been substantially changed since its original construction.

The small storage building to the northwest of the powerhouse was constructed c.1922 for the purpose of storing unused furniture. The building has substantially deteriorated and is currently used for storage and as a workshop.

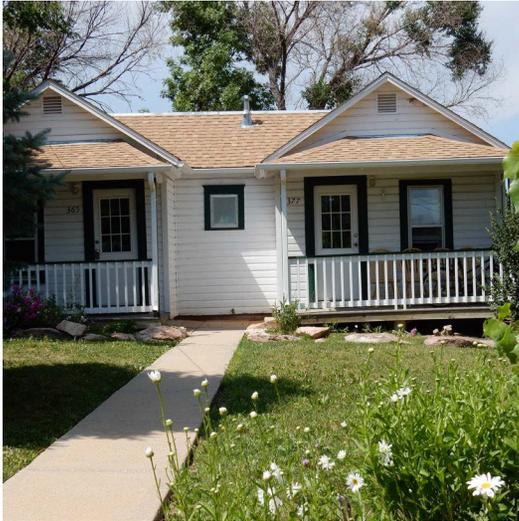
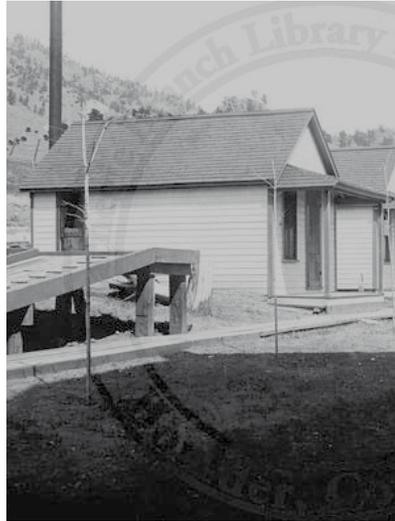
4. COTTAGE A

24. The two ends of cottage A were most likely built separately around 1922 and moved to their current location and connected around 1931. However, they clearly resemble the cottages built on the Sanitarium site in 1906.

The cottage building that sits in between the nurse dormitory and the powerhouse was most likely constructed as two separate buildings, but connected and moved to its present site around 1931. The two cottages that make up the ends of the buildings were likely built around 1922. They do, however, bear a striking resemblance to the cottages built around 1906. The roofing, windows and doors appear to have been replaced fairly recently. However, the siding and window details appear to be original.

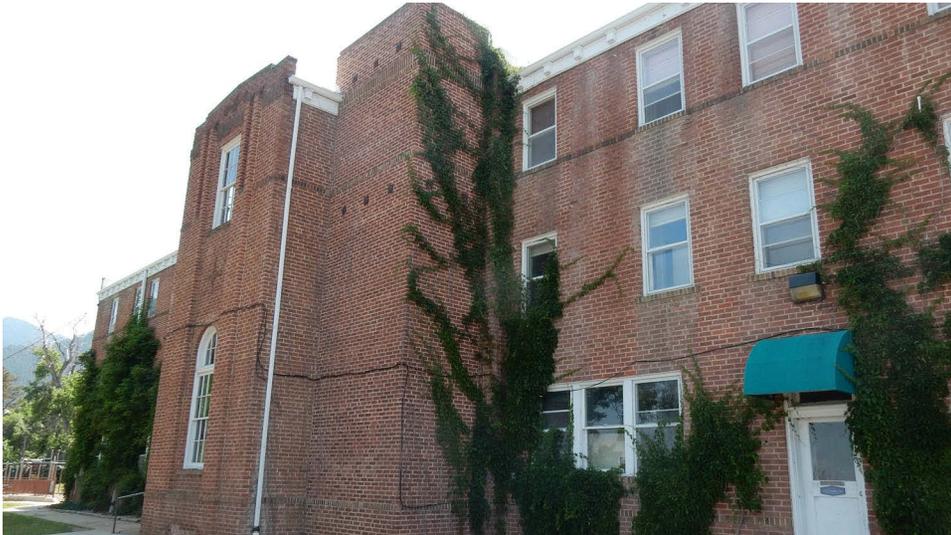
5. NURSE DORMITORY

25. The nurse dormitory retains its original brick and architectural features. The only major change is the addition of the elevator shaft which can be seen as the slightly redder brick tower feature.

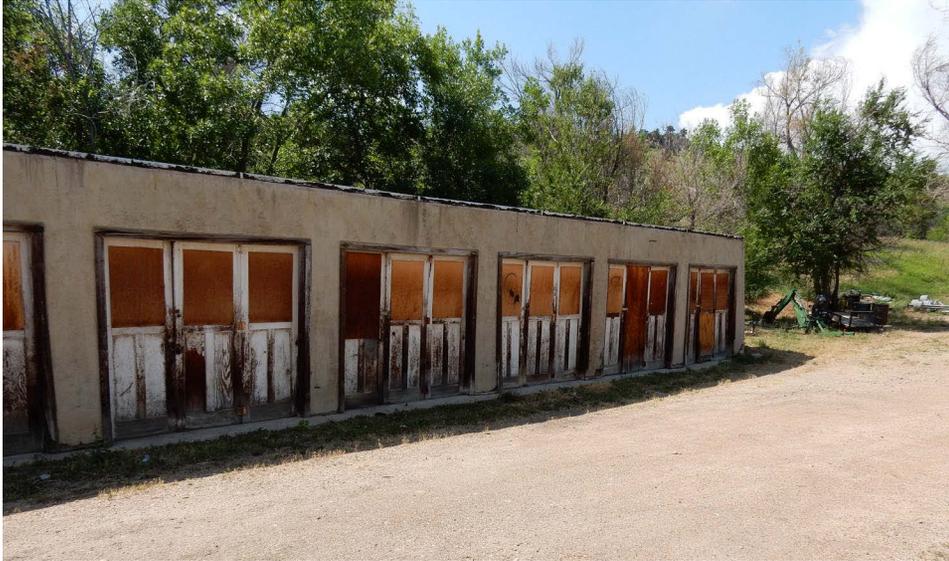
6. GARAGE

26. The garages have deteriorated greatly and have not retained their original building materials.

The garage building to the northwest of the furniture storage building was constructed c.1931. The building still has the 8 separate garage bays it was built with, but the building has deteriorated substantially.

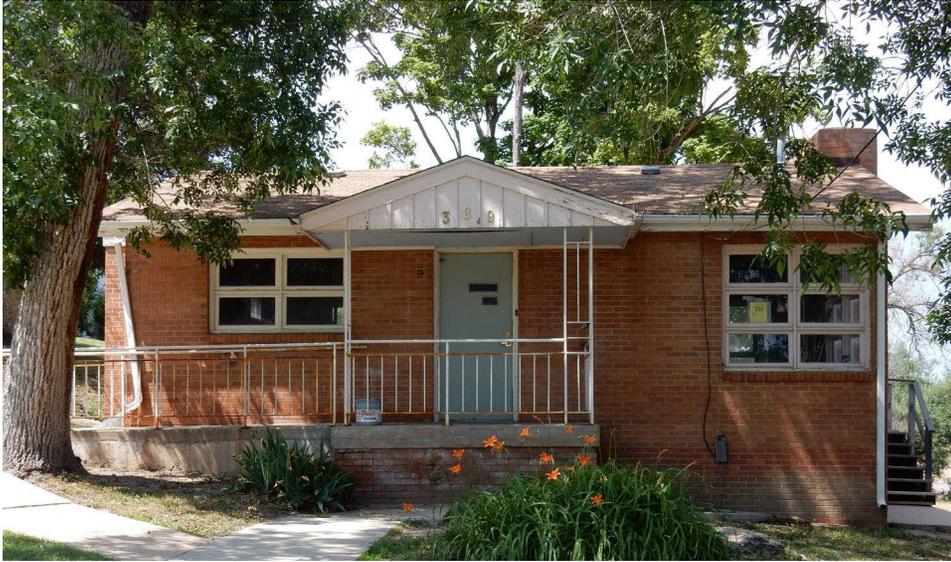
7. COTTAGE B

27. Cottage B resembles a 1950's single-family home built in the post-WWII modern architectural style.

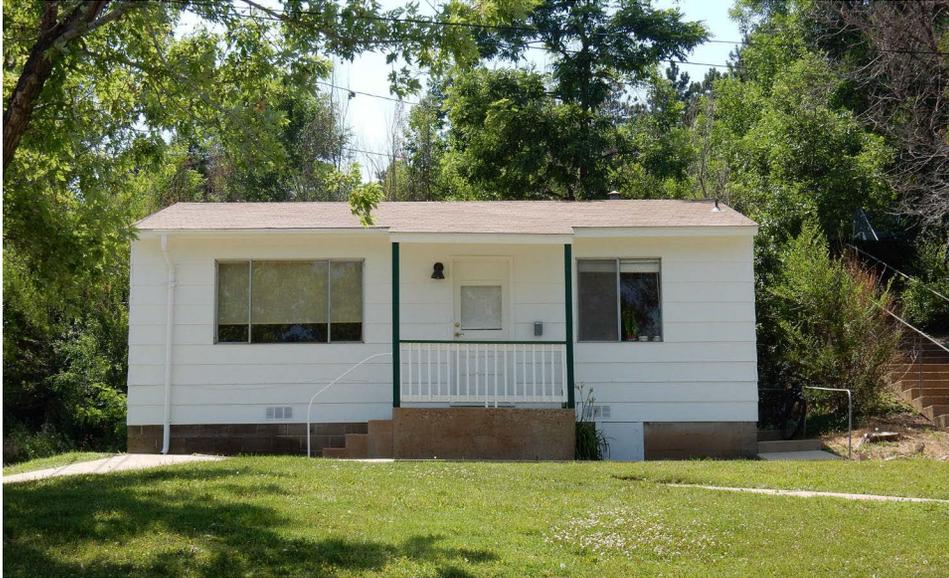
8. COTTAGE C

28. Cottage C appears to have newer windows and roofing materials.

Cottage C is located just to the west of Cottage B, and was also constructed between 1931 and 1962. The building somewhat resembles a simple and boxy post-WWII style and was most likely built in the 1940's. The windows and roofing appear to have been replaced more recently.

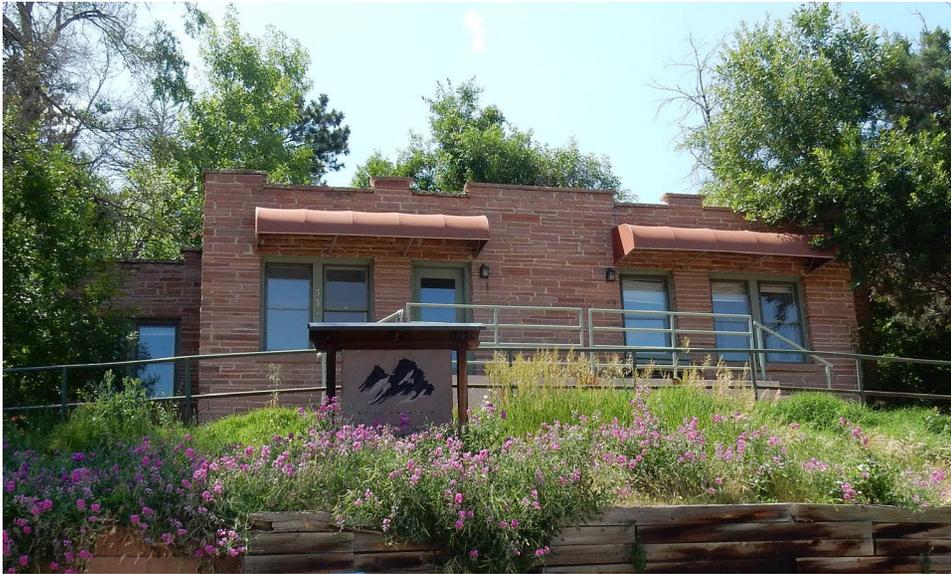
9. COTTAGE D

29. Cottage D has a unique flagstone construction with interesting variations in parapet height.

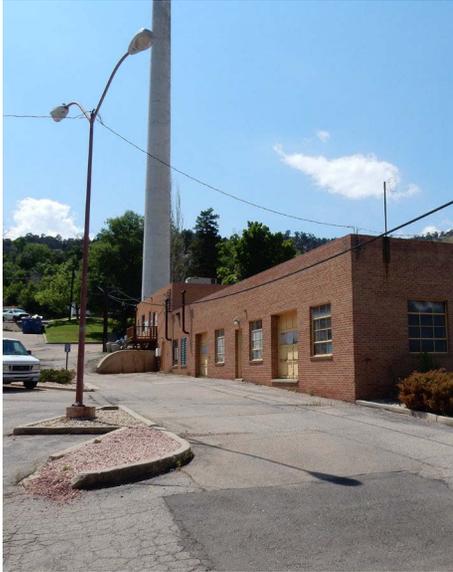
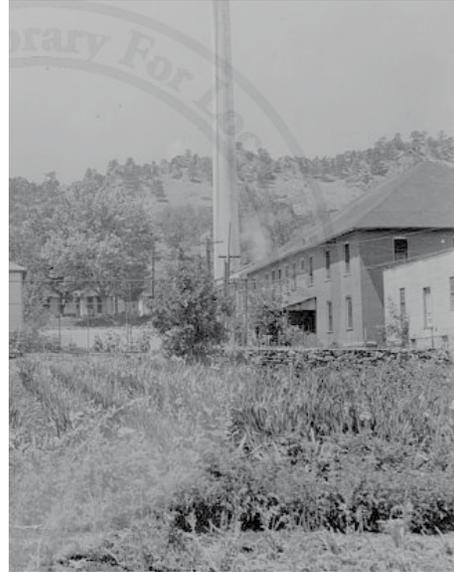
10. POWERHOUSE

30. The current powerhouse building is completely different than the original structure. The walls openings, roof and materials are all different.

Although some of the foundation of the powerhouse building may be original from the initial construction in 1896, the current powerhouse only dates back to 1957. Various additions and demolitions have taken place and the current structure bears little resemblance to the 1896 powerhouse. The old stone foundation is only visible on the northeast corner of the building.

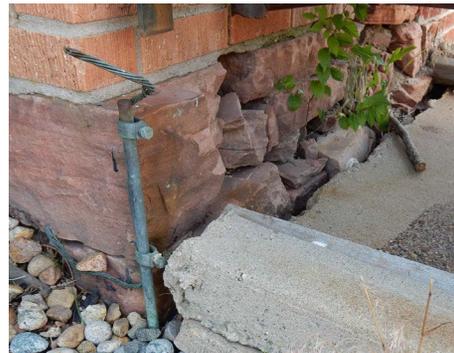
31. A part of an older stone foundation is still exposed on the northeast corner of the building.

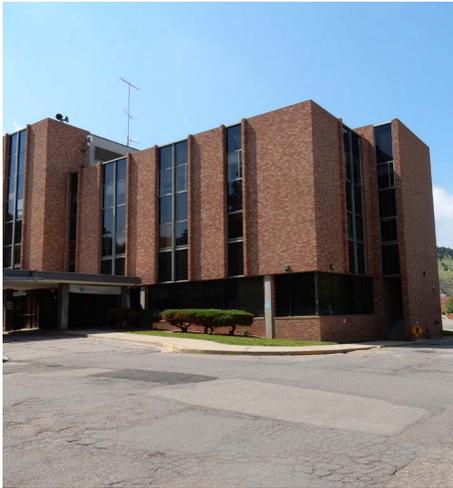
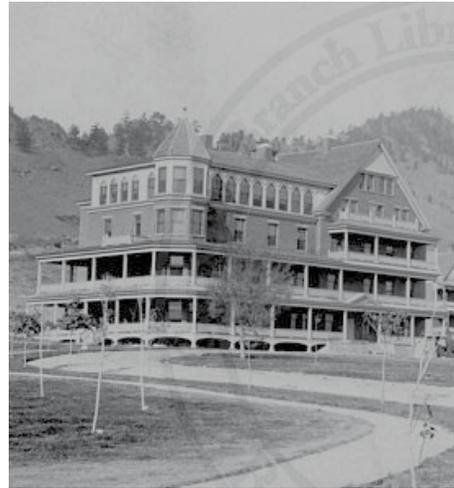
11. MAIN BUILDING

32. The main building exemplifies the constant change that has taken place on the Sanitarium site. The current building has had more than 10 additions just since 1957. None of the original Victorian-style Sanitarium building remains.

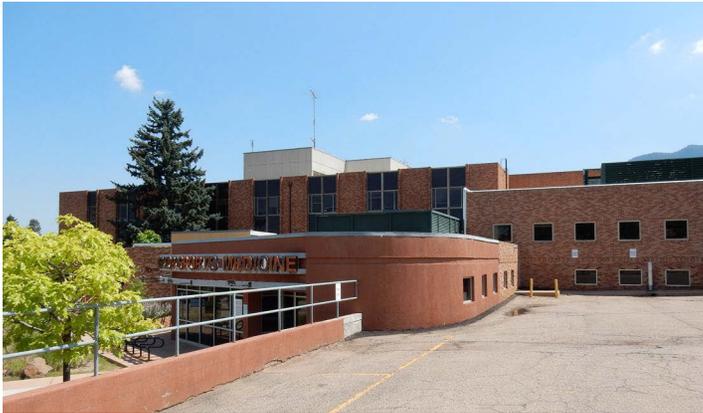
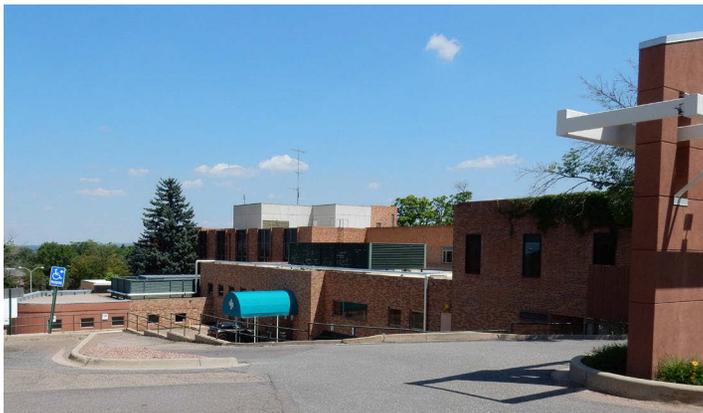
33. The current hospital is a patchwork of different construction

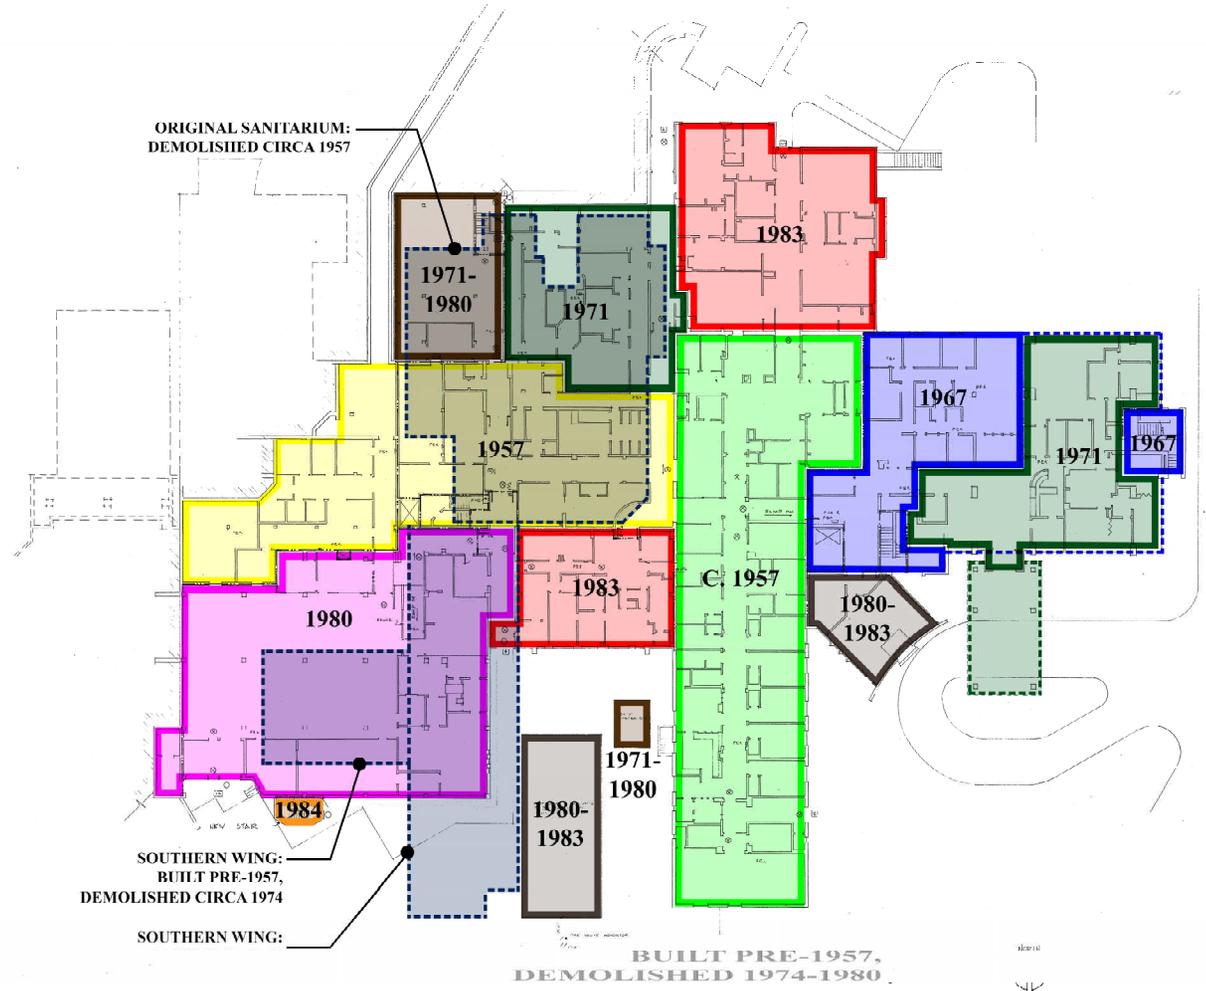
34. Since 1957, the main building has had over 10 major additions

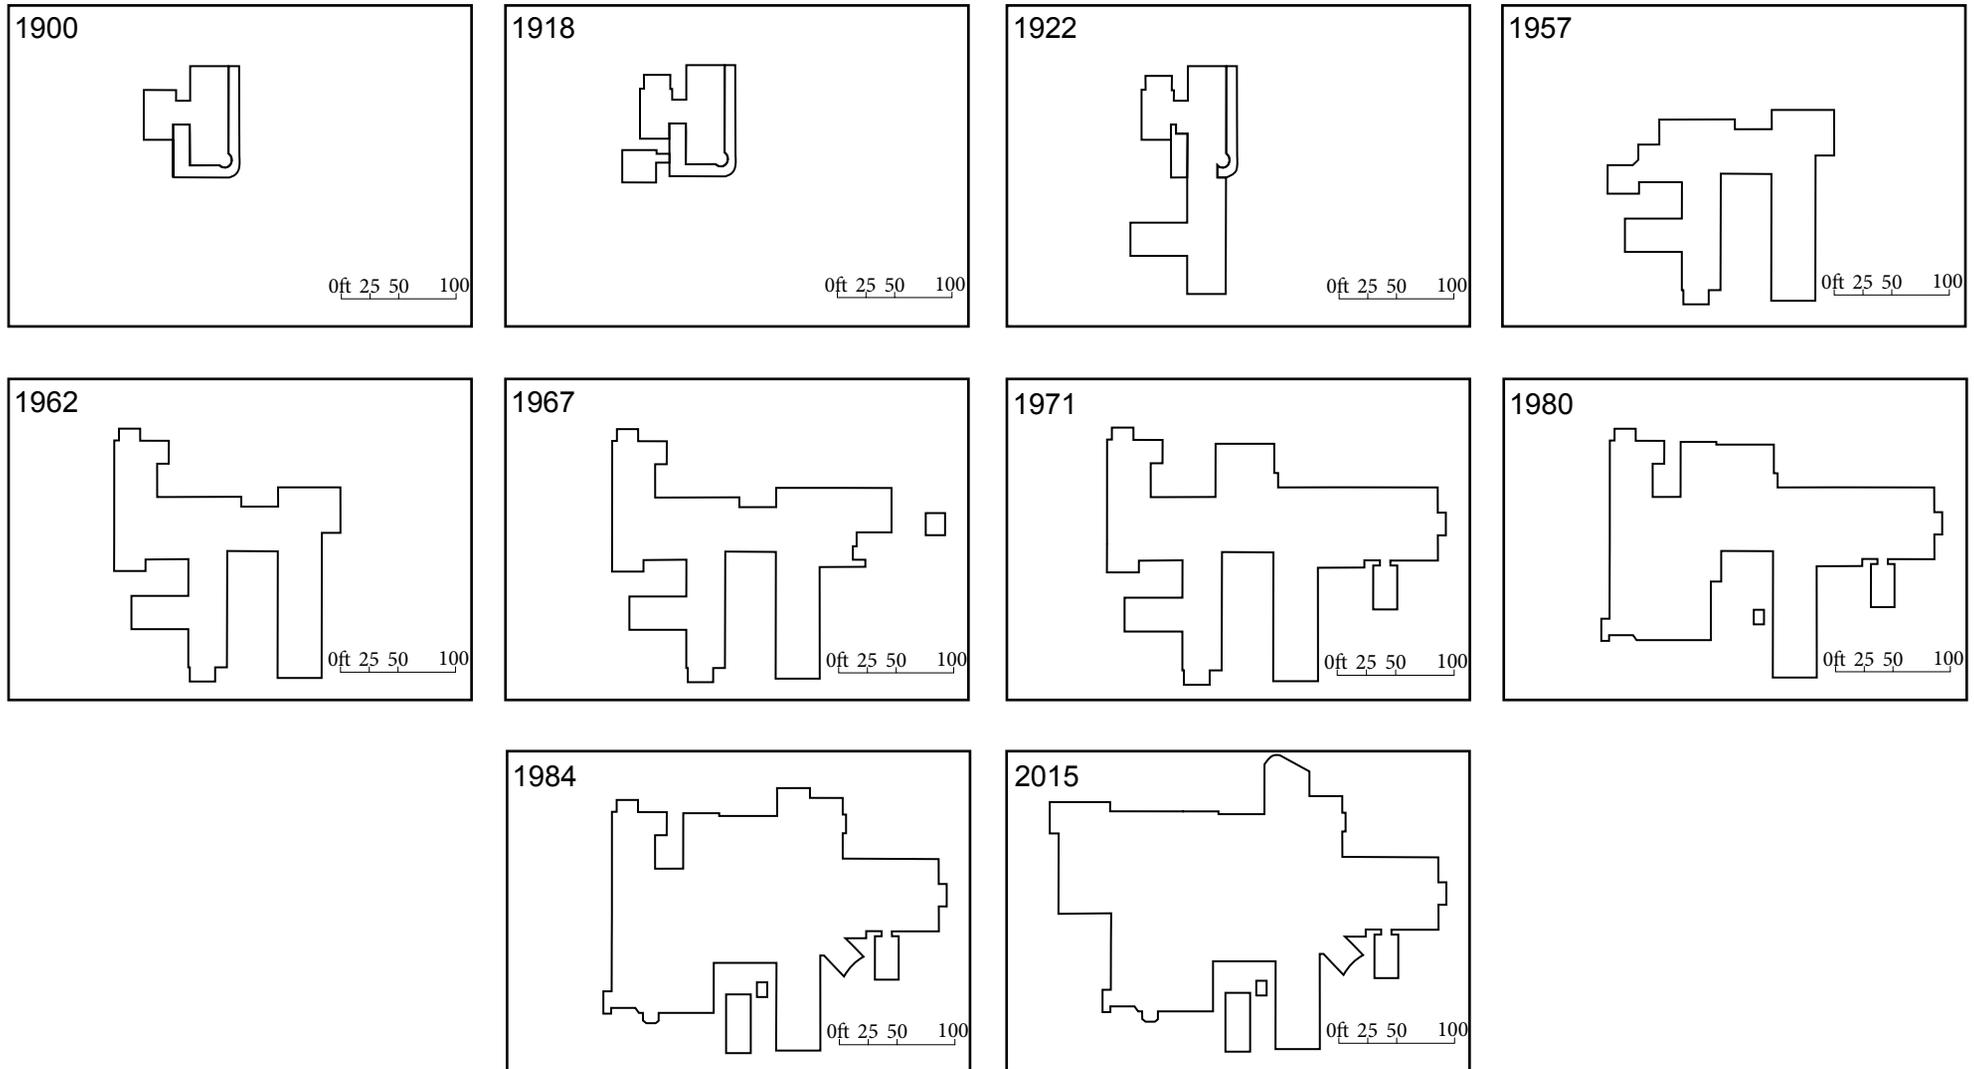
The following graphics show the evolution of the main building. The graphics are based on historical Sanborn insurance maps and building plans.
